# **Rehabilitation of Portland Cement Concrete Pavements With Thin Asphalt-Rubber Open Graded Friction Course Overlays In Arizona**

**Douglas D. Carlson**

Rubber Pavements Association 1801 South Jentilly Lane Suite A-2 Tempe, Arizona 85281-5738

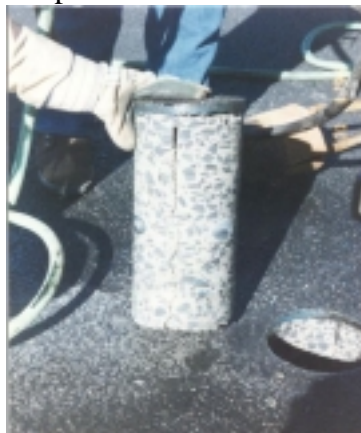
**Figure 2.** A core specimen of a thin AR-ACFC on PCCP.

Three of the 76 projects that have met or exceeded the seven to ten year design life are reviewed. These three were selected based on their age, traffic loadings and locations, but specifically for the unique placement of the thin overlays directly on aged, structurally sound PCC Pavements that were in need of a surface treatment to improve the ride and friction characteristics. An example of this type of overlay can be seen in a photograph supplied by ADOT in Figure 2.

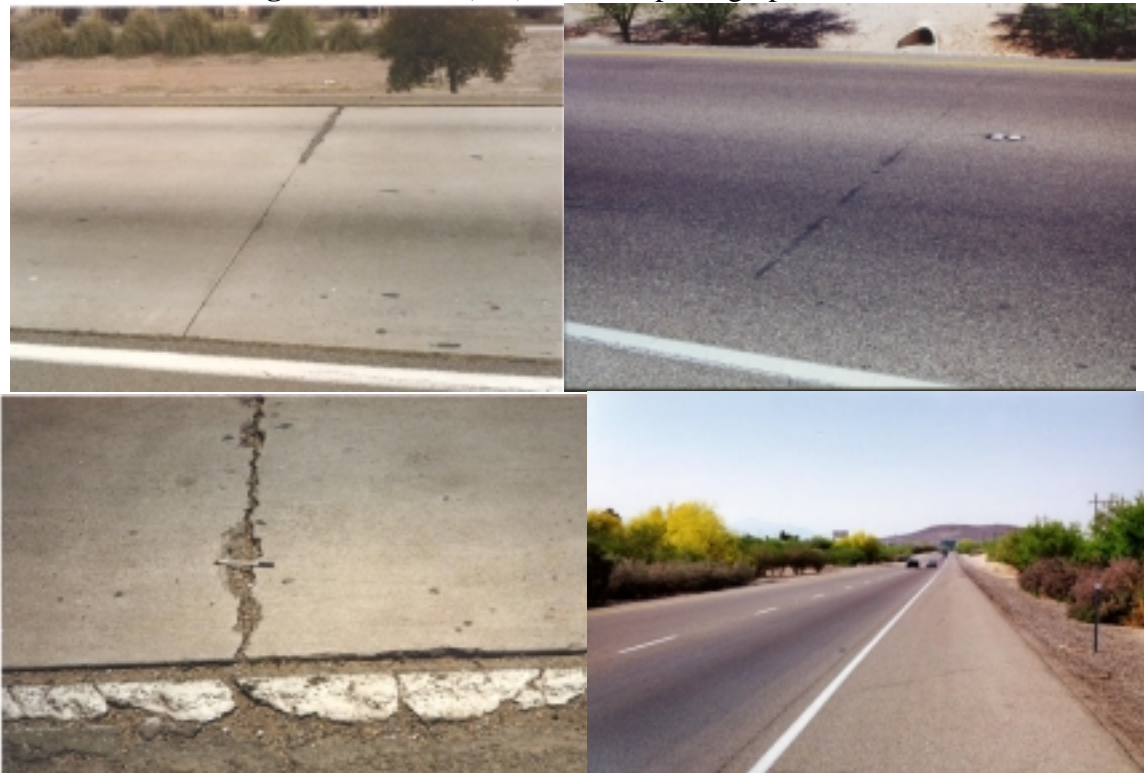
**Figure 3.** Before (left) and after photographs of I-19

A visual inspection of the project revealed that the overlay was still in excellent condition. There was no discernable rutting nor was there any evidence of maintenance repairs. There were a very limited number of reflective cracks above the underlying joints and these

cracks are all hairline in width or they are “ghost” cracks and are completely closed in the wheel paths. Noise measurements were not made but there is a very discernable difference in noise level between this pavement and the adjacent pavements. A noise study conducted by ADOT in 1989 indicated a 6.7 dB reduction when comparing the AR-OGFC overlay to an adjacent PCCP.<sup>10</sup> Before and after photographs are presented as Figure 3. As of this writing, the overlay has been milled and replaced as part of another project. The project had doubled the expected seven year design life.

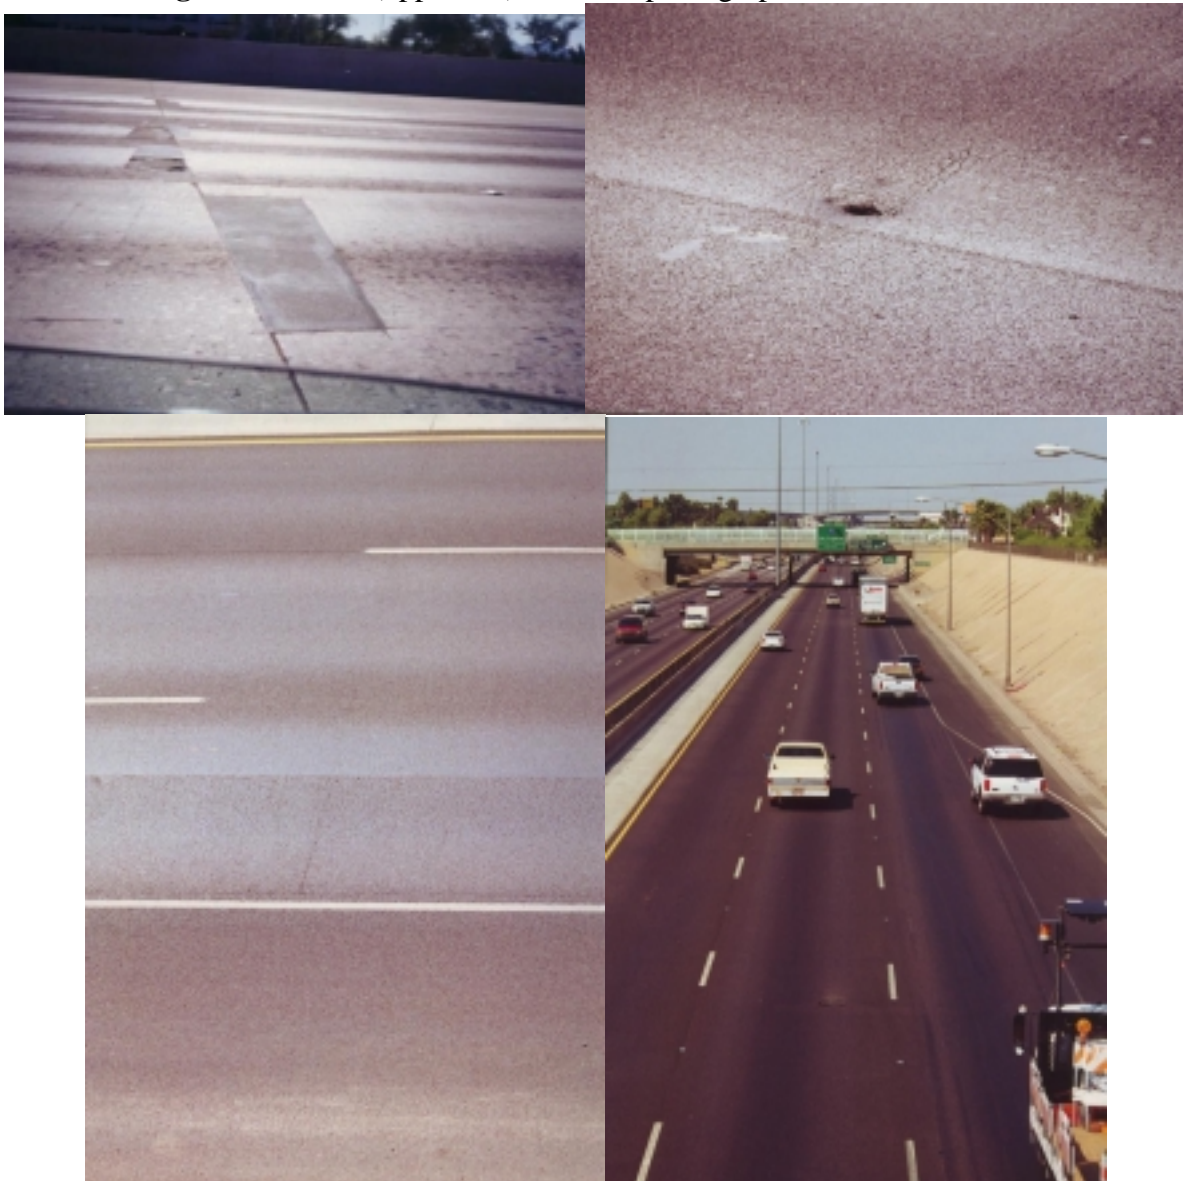
**Figure 4.** Before (upper left) and after photographs of I-17 in Phoenix

Photographs from the recent inspection are displayed in Figure 4. The pavement is in good condition and the overlay has provided excellent service over it's twelve year life.

A visual inspection in 2000 revealed the following conditions:

- 1) All joints had reflected through in the distress lanes and the shoulder but the cracks were either closed or hairline in the travel lanes.
- 2) Some structural failure had occurred with three potholes developing. The holes were relatively equidistant and inline with each other. The pattern suggests underlying repair work to the longitudinal joints prior to the overlay, which can be seen in the top right of Figure 4. These holes have been recently been patched with a quick setting concrete.
- 3) Noise reduction is good.
- 4) Ride is smooth.
- 5) Overlay color is still a very dark black which provides good contrast to pavement markings, striping, and reflectors.

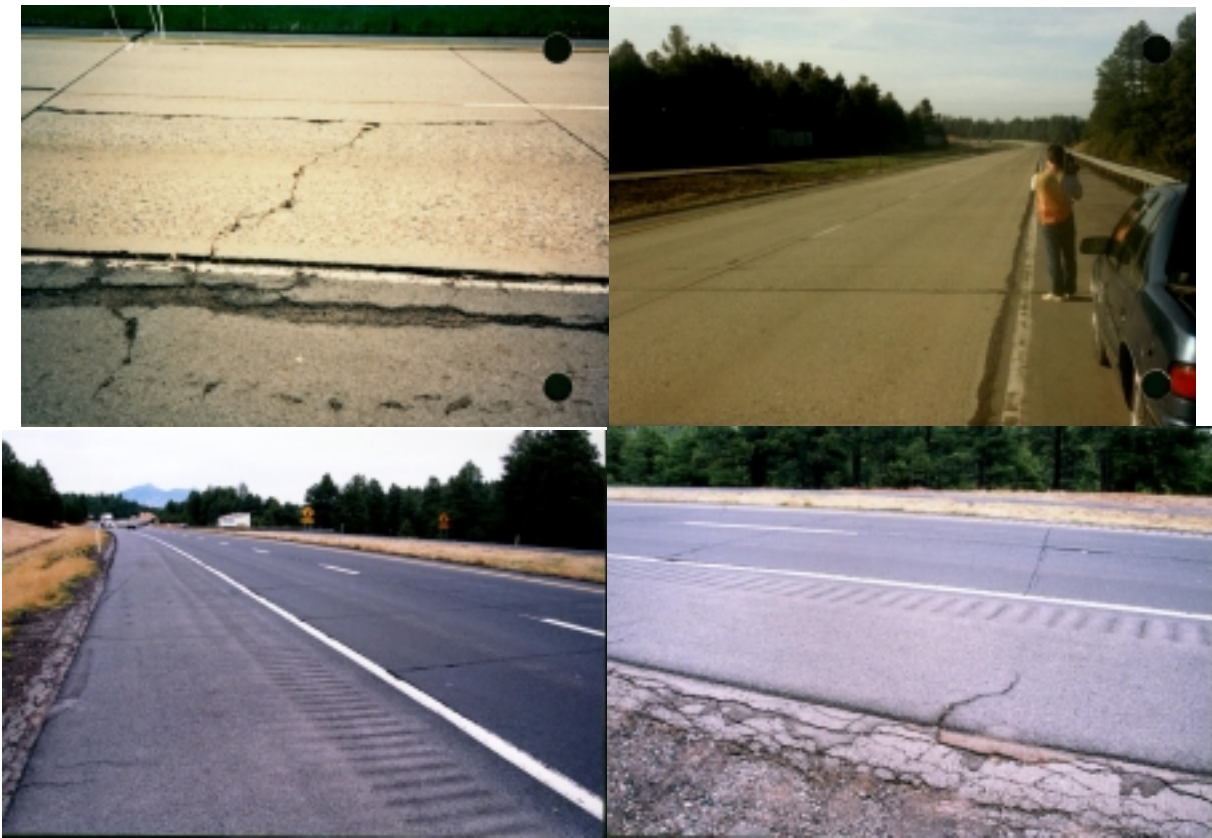
**Figure 5.** Before photos on top, after photos below

Some areas along the project have been repaired due to continued deterioration of the underlying concrete and sub-grade materials. Although the reflective cracking above the joints are more pronounced on the project, they are not spalling. The lower portion of the project near mile post 335 indicates that a rejuvenator has been applied. This project is near the end of its design life may be scheduled for a mill and replace activity in the next few years. Performance data is listed in Table 3 and before and after photographs are displayed in Figure 5.
